SIMPLIFIED SAFETY INVESTIGATION REPORT

REPORT NO.: 17/2016

MY *Namaste 8* **Serious injury to passenger** **while using a powered surfboard** **03 September 2015**

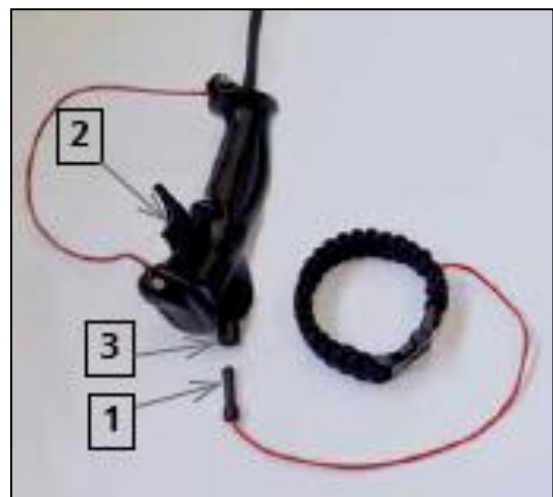
Figure 2: Surfboard's control handle – (1) starter key with kill cord, (2) trigger to control throttle cables, (3) ignition slot

The propulsion and speed of the surfboard is controlled by the rider using the throttle trigger in the control handle. In the event of the rider falling off the board and the control handle dropped, the ignition key is pulled out, quickly disengaging the engine.

The master recalled that when the passenger fell from the surfboard, the latter kept her grip on the control handle. With the trigger

depressed, the surfboard accelerated forward as it reached the end of the throttle cable. Before the control handle was released, the surfboard pivoted on the throttle cable, changed direction and eventually struck her on the head.

17/2016_R2 issue a safety alert to highlight the importance of releasing the control handle as soon as the rider falls from the surfboard;

17/2016_R3 consider a failsafe design which ensures that the engine is shut down without relying on the operator's release of the control handle;

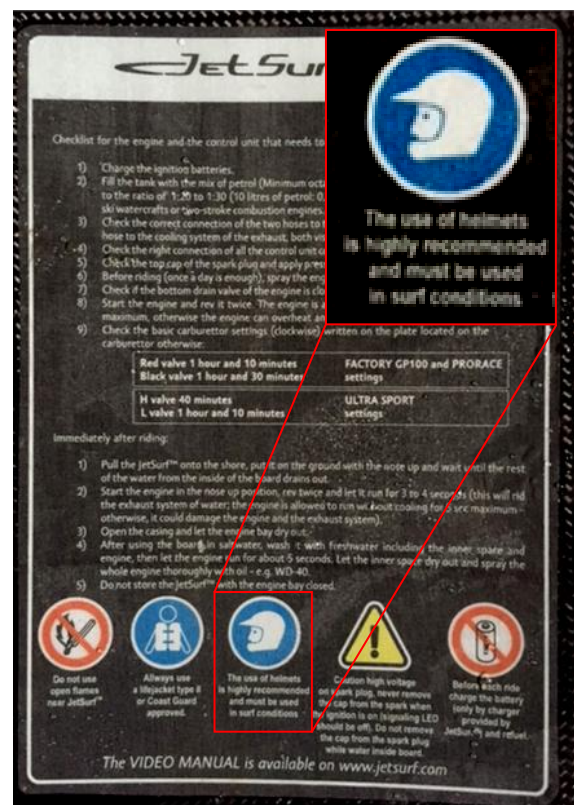
been successful. Nonetheless, the jet surfboards came with an illustration of five key symbols and a checklist for the engine and control unit. One of the symbols displayed a graphic image of a helmet with a caption ‘the use of helmets is highly recommended and must be used in surf conditions’ (Figure 4).

Figure 4: Safety symbols displayed on the surfboard

The same conflicting messages were also observed in the User Manual and the illustration on the surfboard (with respect to the wearing of the safety helmet). Whereas, the User Manual emphasised that it is *mandatory* to wear a safety helmet, the illustration on the surfboard made a *recommendation* to this effect.

17/2016_R5 amend all the safety instructions in order to ensure that there are no conflicting messages with respect to wearing of the safety helmets.
