SIMPLIFIED SAFETY INVESTIGATION REPORT

REPORT NO.: 17/2016

MY *Namaste 8* **Serious injury to passenger** **while using a powered surfboard** **03 September 2015**

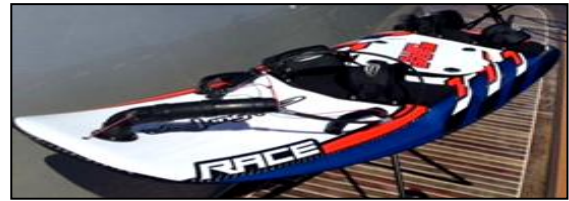
The powered surfboards were designed by race engineers (Figure 1) manufactured by JetSurf s.r.o, Brno, Czech Republic. The boards were handmade and manufactured from carbon fibre. Each had a two-stroke internal combustion engine, powering a water-jet pump for propulsion.

Figure 1: The powered surfboard available on *Namaste 8*

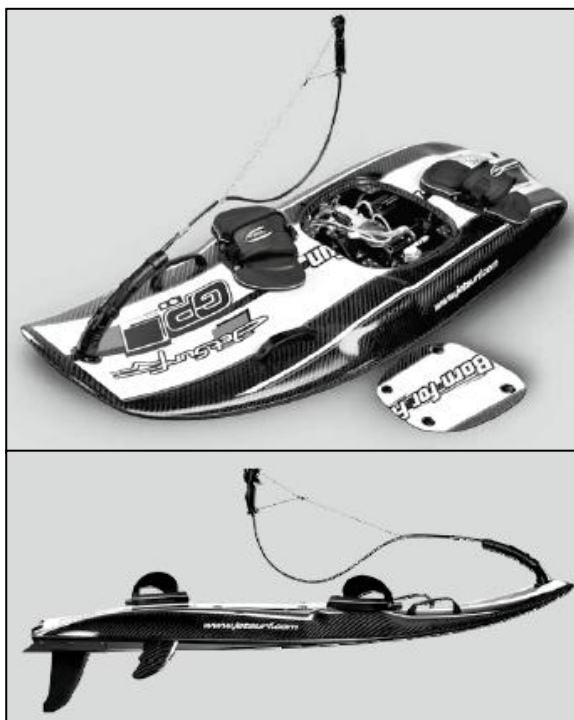
On 06 August 2015, an instructor travelled to La Ciotat, France to provide practical training and instructions to three of the yacht's crew members. For this purpose, he was using a demonstration surfboard. On 29 August 2015, two powered surfboards – JetSurf Factory GP100² were delivered in Ajaccio, Corsica (Figure 3).

Figure 3: Powered surfboard profile
